El Dorado Hills

**Subject: Rancho Murieta Community Services District
Dam Inspection Report Evaluation to support the 2024 Capital
Improvement Planning Efforts**

Name of Dam Chesbro Dam No. 1450-2

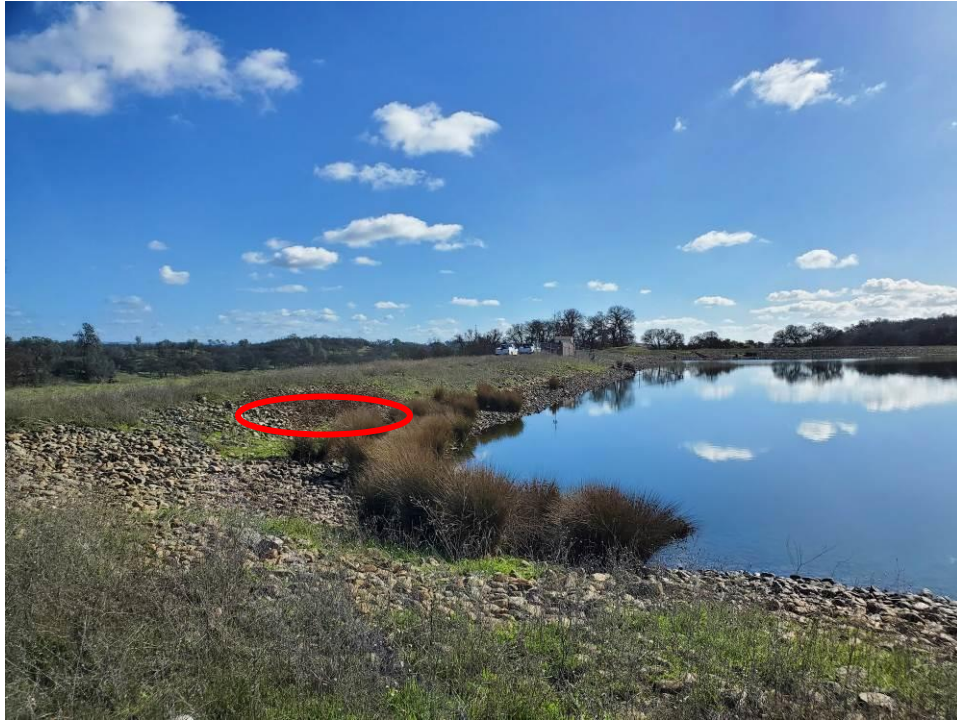
Photo 1: View of the upstream face of the Middle Dam (near) and South Dam (far) from the left side of the Middle Dam looking towards the right. The berry vine growth in the red circle needs to be removed.

- Chesbro Dam
 - Clear the fallen limbs from the oak tree on the downstream left groin of the North Dam.
 - Remove the berry vine growth from the upstream face of the Middle Dam.

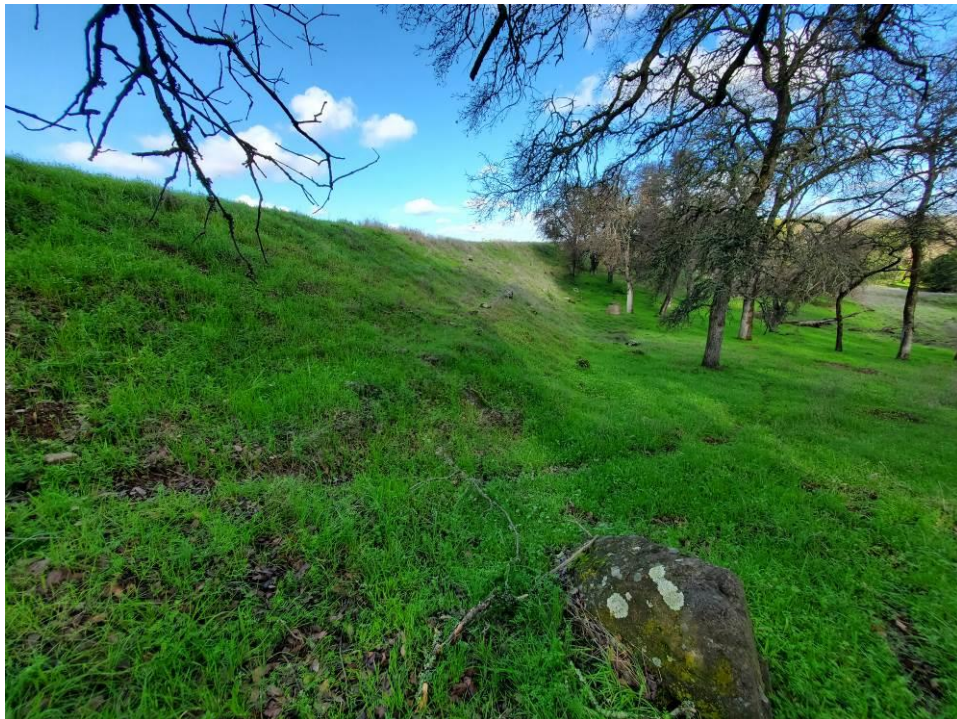
Photo 2: View of the downstream face of the South Dam from the right side looking towards the left.

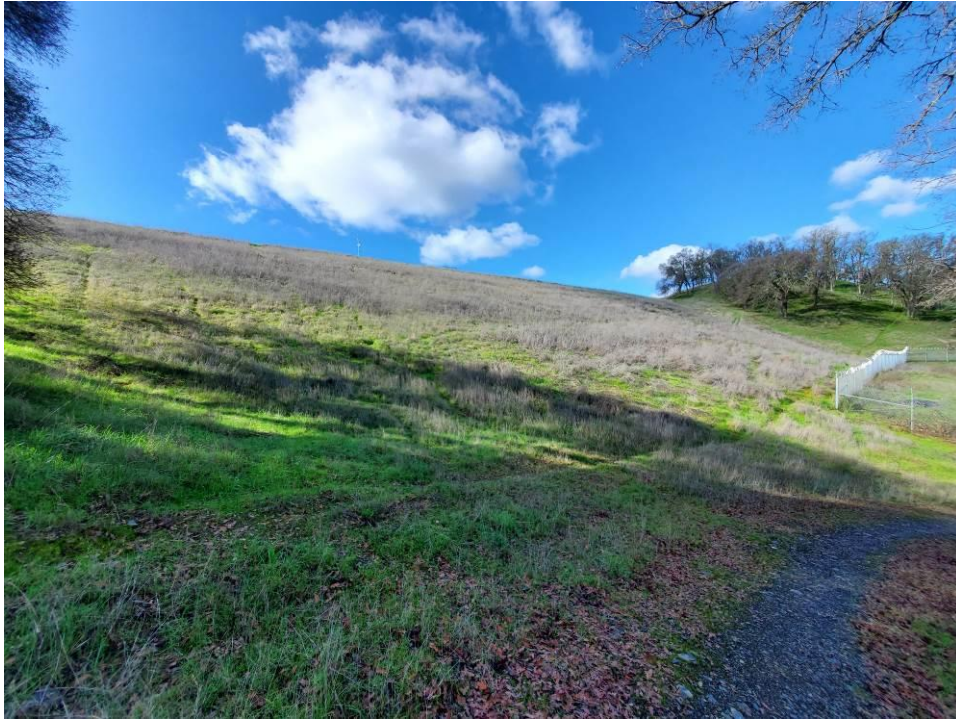
Photo 3: View of the downstream face of the Middle Dam from the right groin near the toe looking towards the left groin.

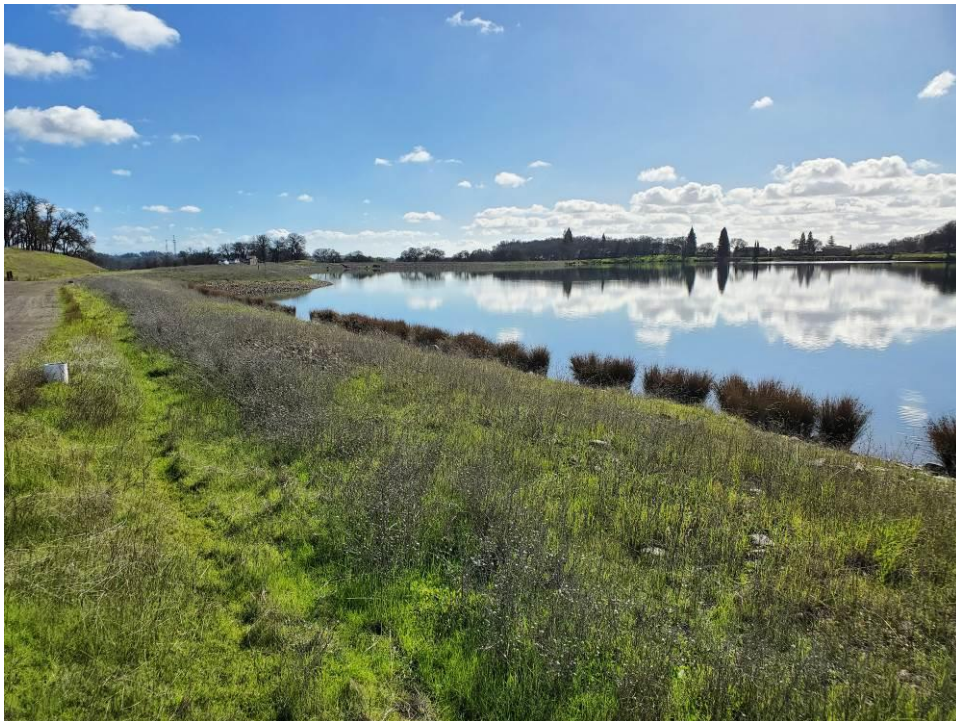
Photo 4: View of the upstream face of the North Dam from the left side looking towards the right.

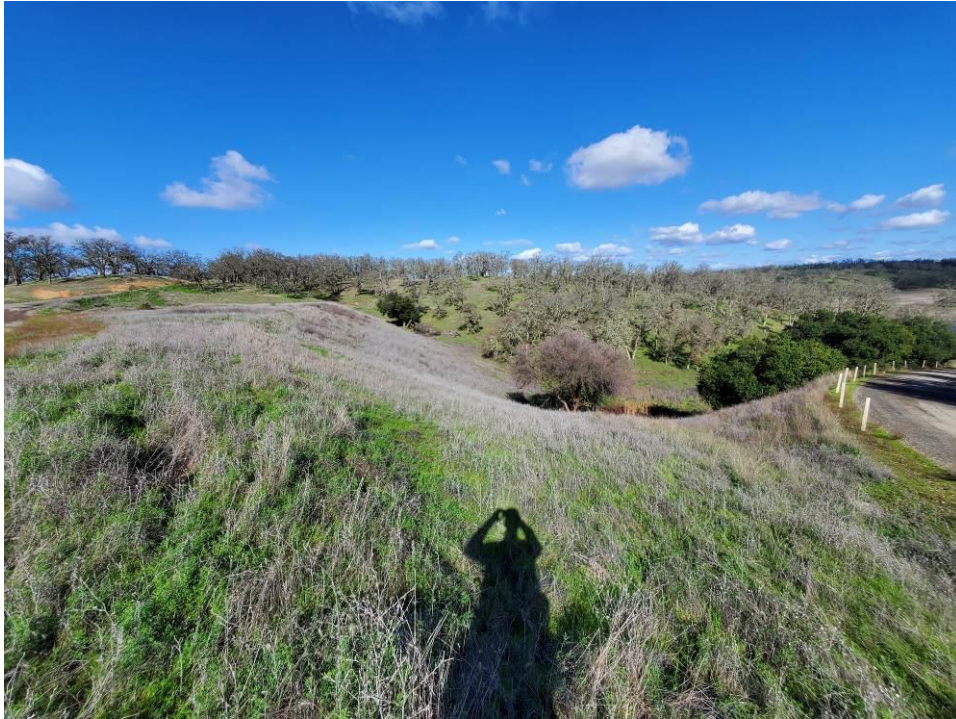
Photo 5: View of the downstream face of the North Dam from the right side looking towards the left.

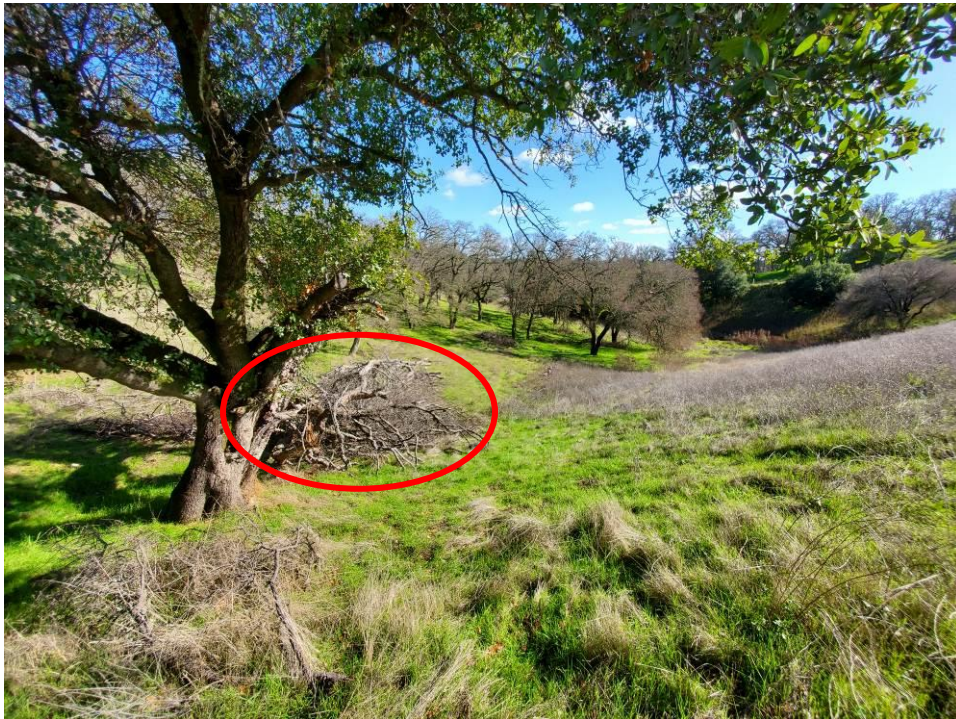
Photo 6: View of the downstream face of the North Dam from the right groin looking towards the toe. The fallen limbs shown by the red circle need to be removed.

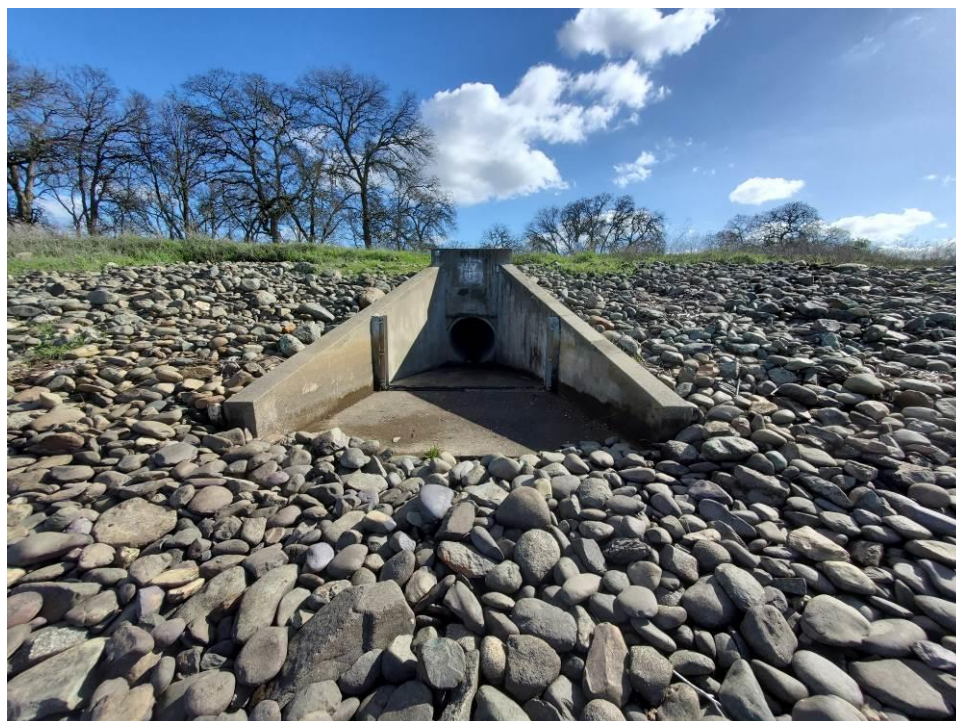
Photo 7: View of the spillway approach and control section.

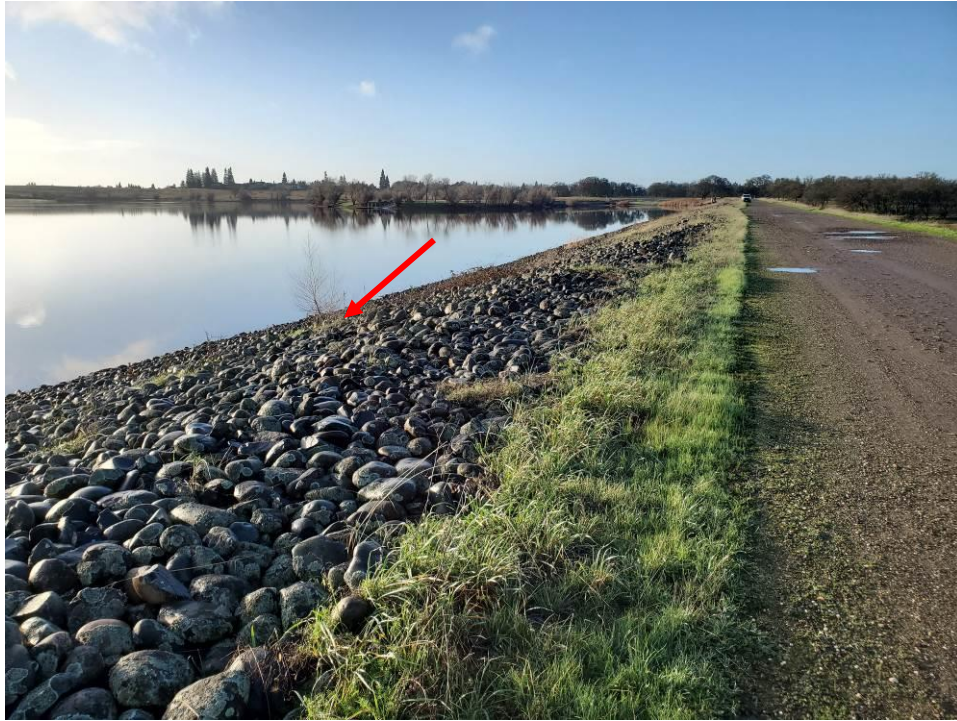
Photo 1: View of the upstream face of the Main Dam from near the right abutment looking towards the left. The small tree shown by the red arrow needs to be removed.

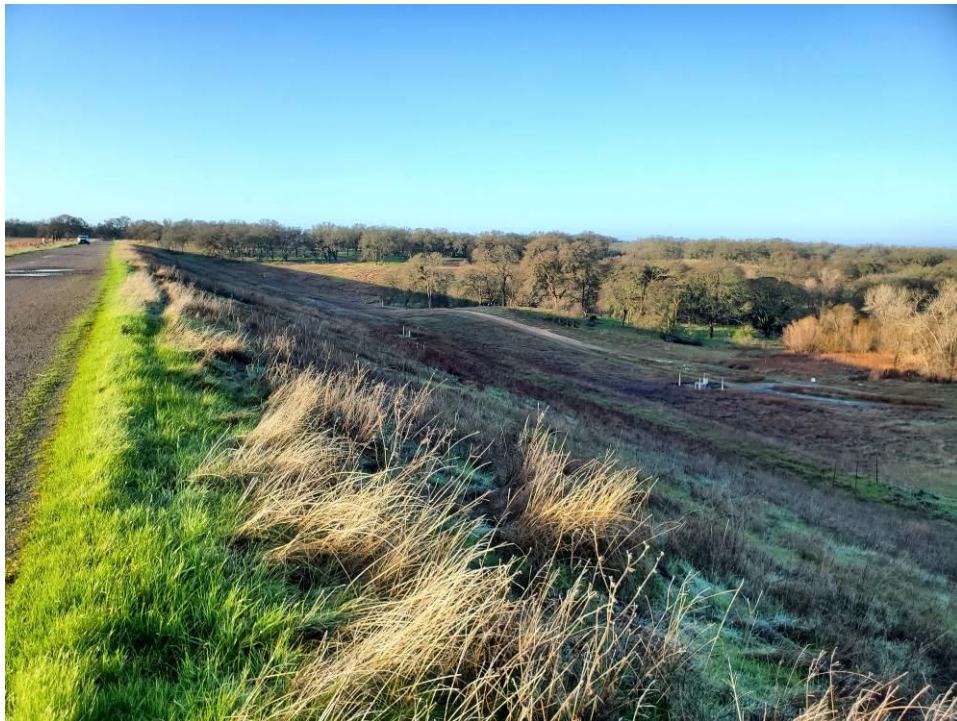
Photo 2: View of the downstream face of the Main Dam from near the right abutment looking towards the left.

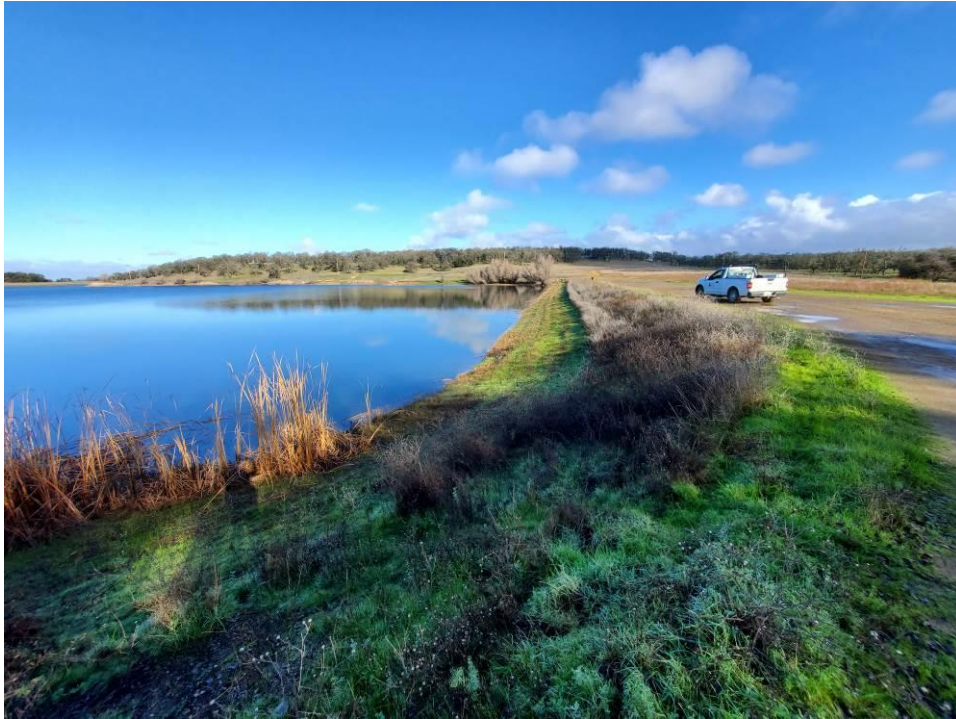
Photo 3: View of the upstream face of the East Dam from near the right abutment looking towards the left.

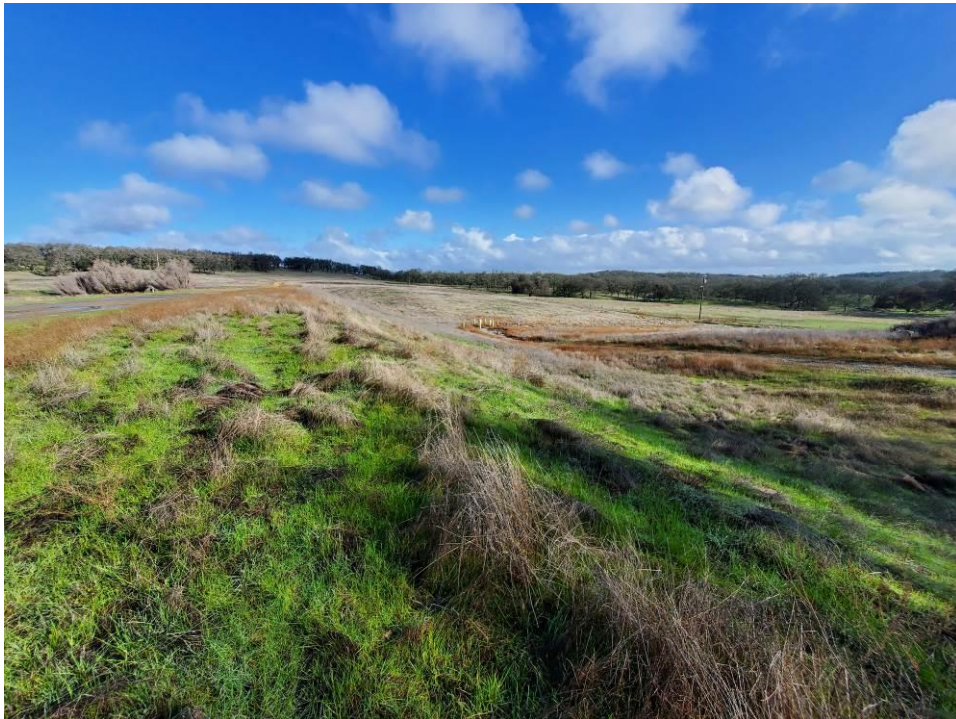
Photo 4: View of the downstream face of the East Dam from near the right abutment looking towards the left.

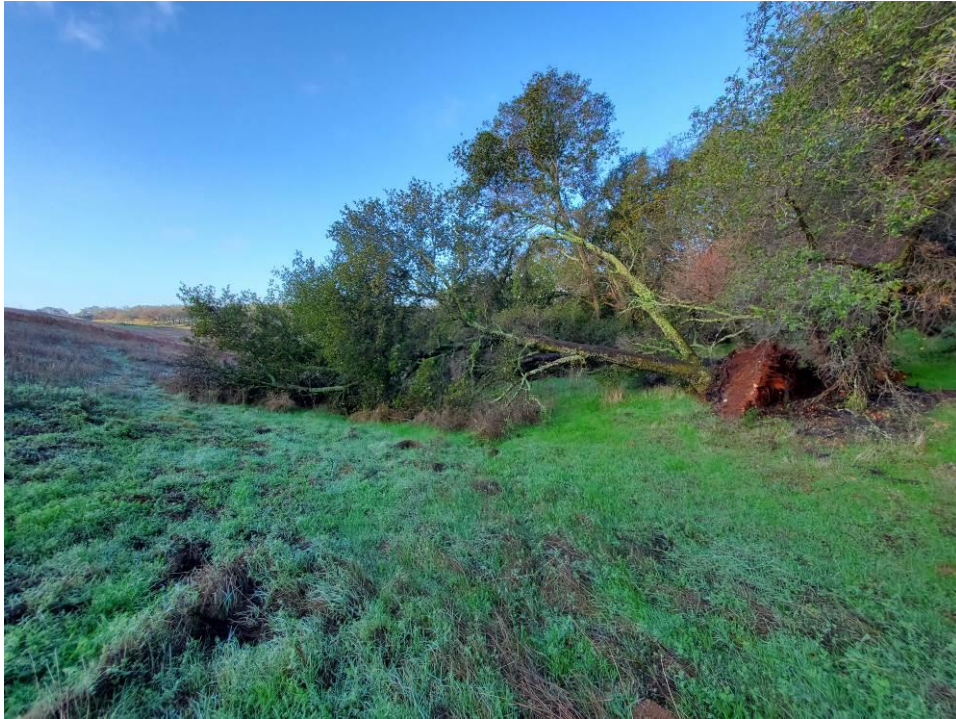
<p>Vegetation control was satisfactory apart from sporadic small woody vegetation growth on the Main Dam and the fallen oak tree at the toe of the Main Dam that was covering a portion of the downstream face (Photo 5). The fallen oak tree needs to be removed and RMCS D needs to remove the sporadic woody vegetation and small trees as part of their regular maintenance activities. No major rodent activity was observed, but RMCS D needs to continue with their abatement efforts and collapse and backfill burrows with compacted material when encountered.</p>
<u>Spillway</u>	<p>The spillway control section, and concrete pipe were clear and unobstructed (Photo 6). The concrete surfaces were in satisfactory condition. As requested, RMCS D had removed the vegetation and grass growth in the spillway approach. There were no stoplogs in the spillway structure in accordance with the Certificate of Approval which requires the stoplogs be removed between October 1 and April 15 of each year, both dates inclusive.</p>

Photo 5: View of the downstream face of the Main Dam near the middle of the dam. The fallen oak tree in this location needs to be removed.

- The fallen oak tree needs to be removed and RMCSD needs to remove the sporadic woody vegetation and small trees as part of their regular maintenance activities.

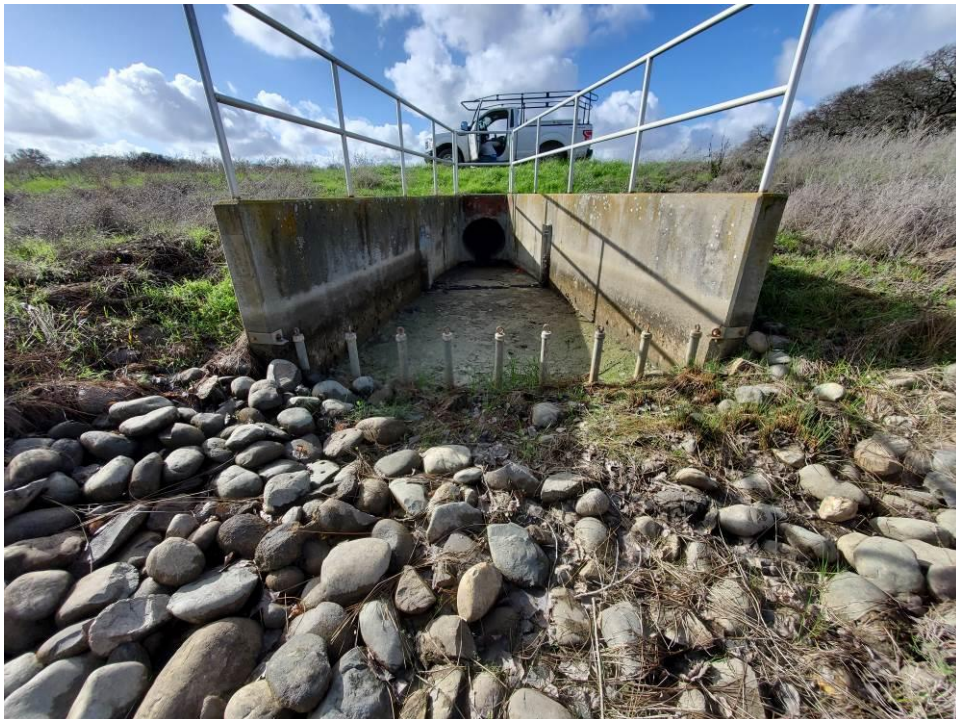
Photo 6: View of the spillway approach and control section looking downstream.

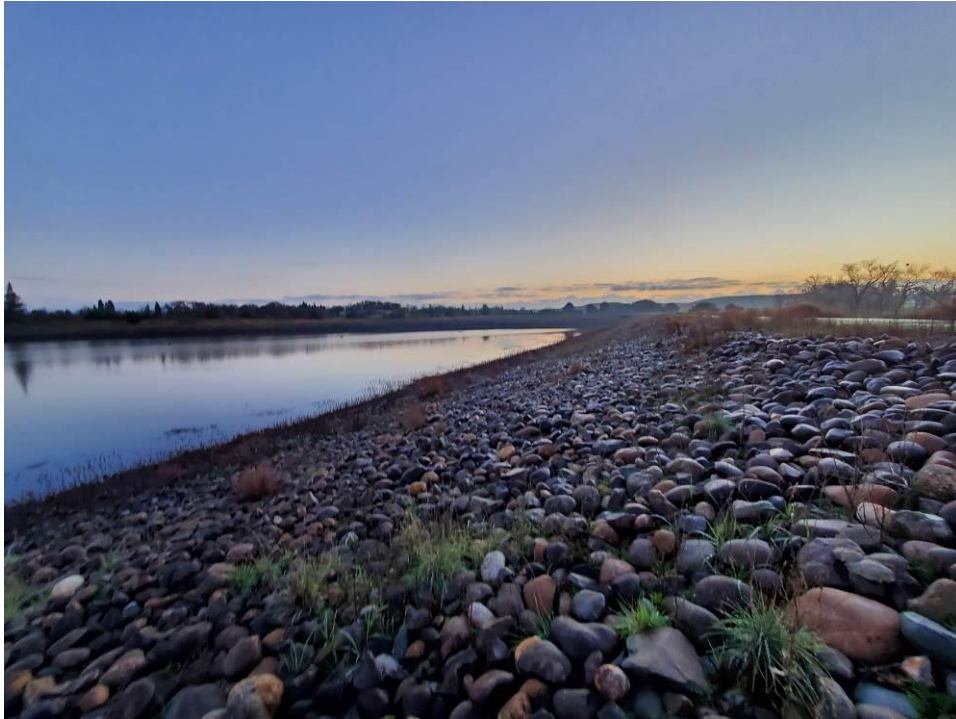
Photo 1: View of the south side upstream face of the dam at Reservoir No. 1 looking east.

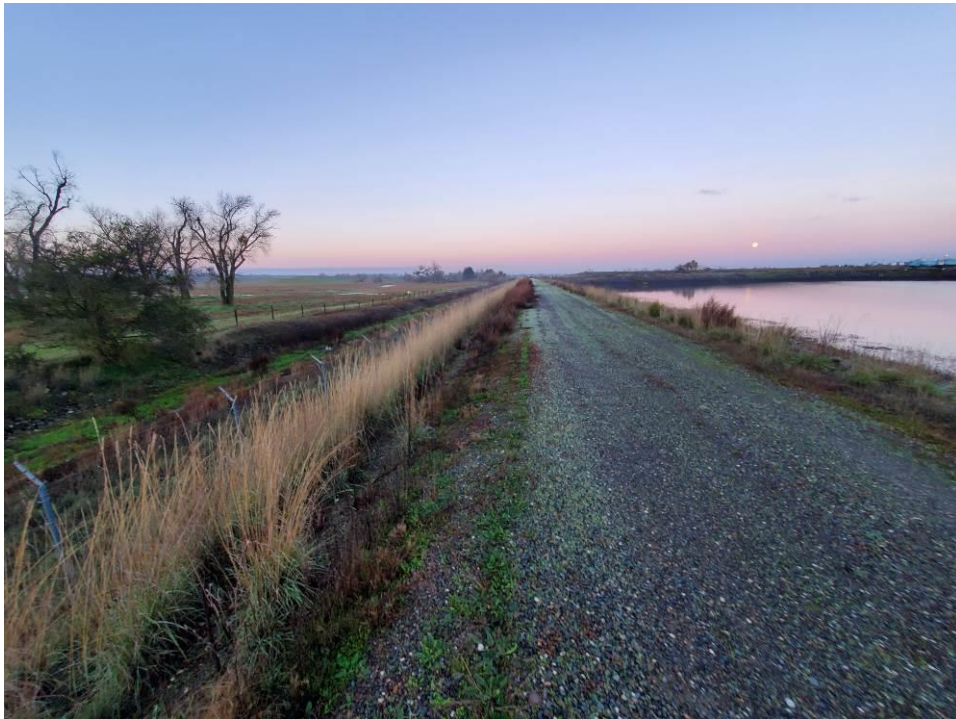
Photo 2: View of the south side crest and downstream face of the dam at Reservoir No. 1 looking west.

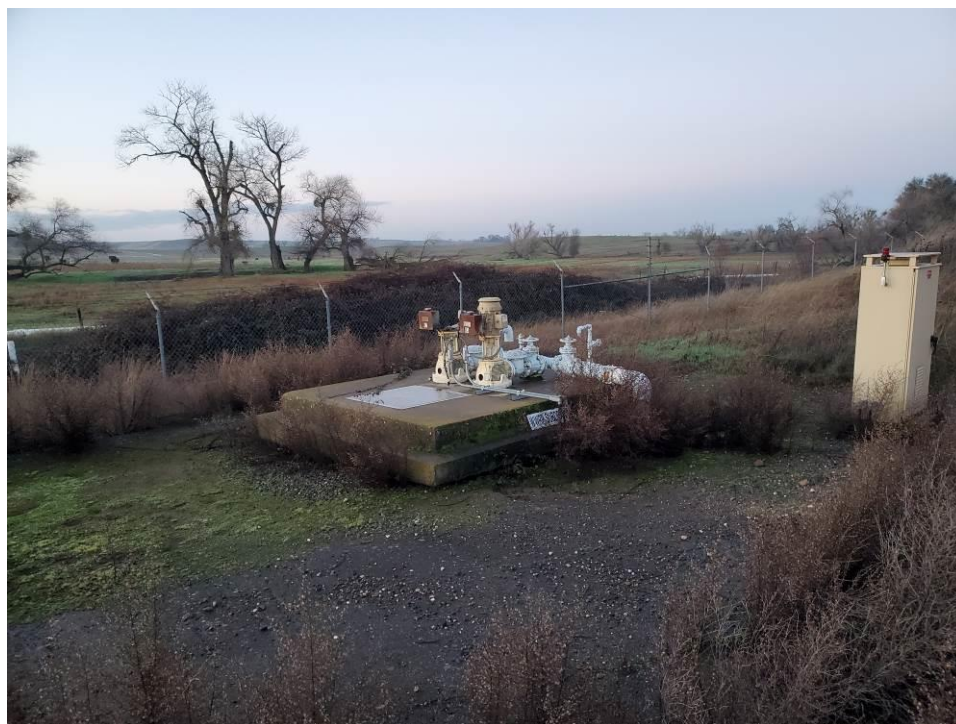
<u>Outlet</u>	The dam does not have a traditional low-level outlet. The reservoir can be dewatered via pumps located at the southwest end of Reservoir No. 1 (Photo 3). The pumps were in satisfactory condition and RMCS D regularly uses them for irrigation purposes.
<u>Seepage</u>	The dam embankment was damp due to recent precipitation, but no other signs of seepage (i.e. live flow, overly saturated ground, abnormally green vegetation) were observed on the downstream faces, toes, or toe ditch of the dams.
<u>Instr.</u>	There is no instrumentation at this dam, and none is deemed necessary at this time.

Photo 3: View of the reservoir dewatering pumps located at the southwest corner of Reservoir No. 1.

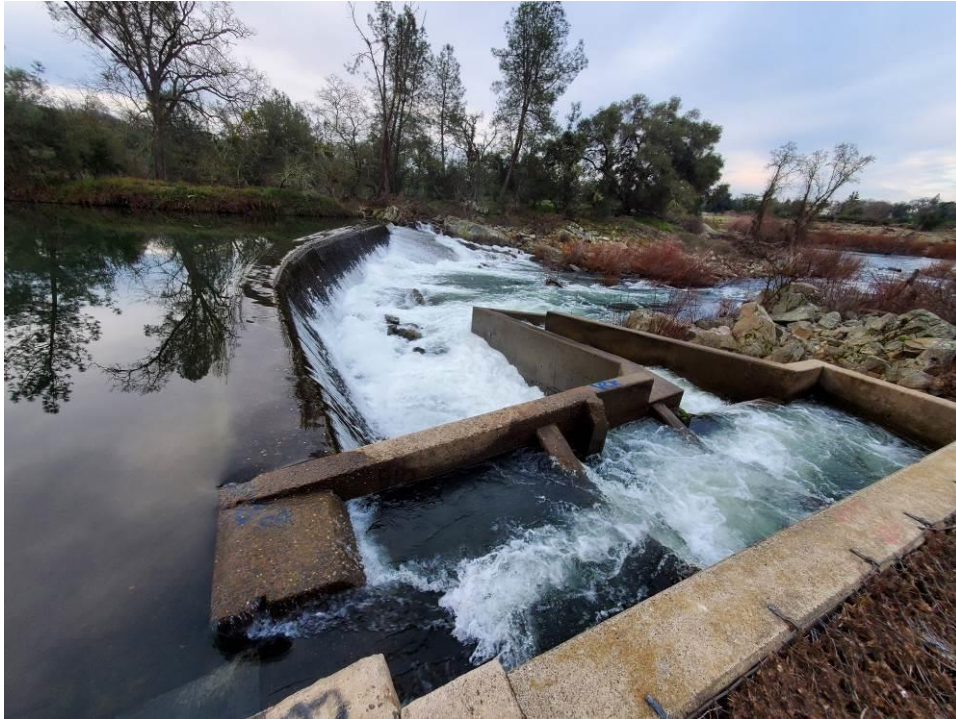
Photo 1: View of the North Dam from the right abutment looking towards the left.

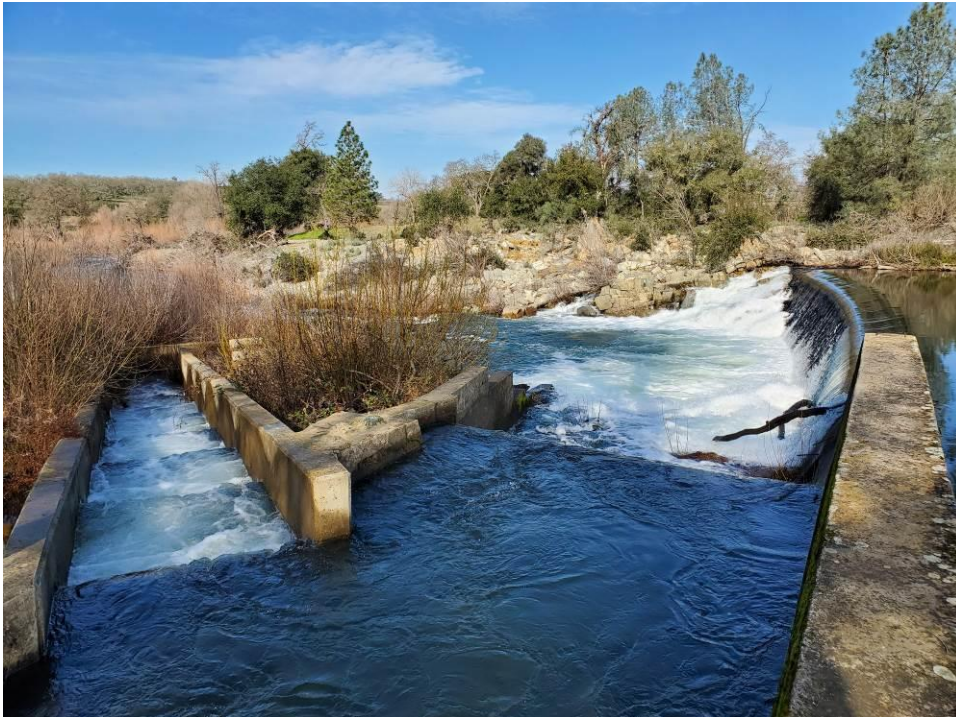
Photo 2: View of the South Dam from the left abutment looking towards the right.

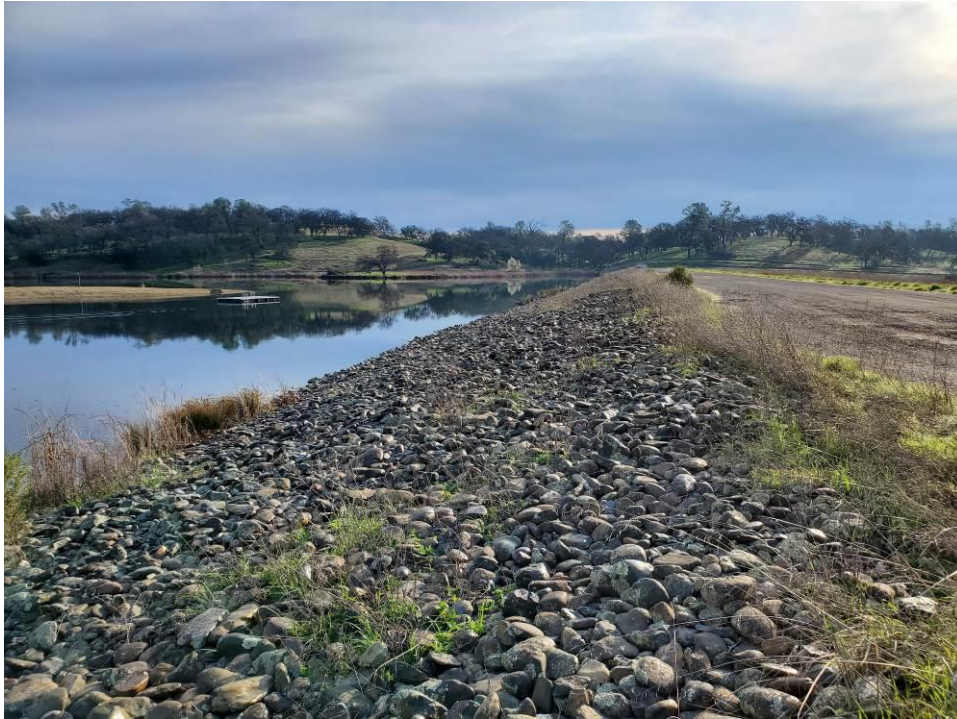
<u>Dam</u>	I walked the crest, downstream groins, and toe of the dam. The crest, upstream face, and downstream face were in satisfactory condition with no signs of instability or distress (Photos 1 and 2). Vegetation control on the dam was satisfactory apart from sporadic woody vegetation growth that RMCS D needs to remove as part of their regular maintenance activities. No major rodent activity was observed, but RMCS D needs to continue with their abatement efforts and collapse and backfill burrows with compacted material when encountered.
<u>Spillway</u>	The spillway, control section, box culvert, and downstream channel were clear and unobstructed. The concrete structure remains in satisfactory condition. Stoplogs were not in place, in accordance with the Certificate of Approval which requires the boards be removed between October 1 and April 15 each year, both dates inclusive. As requested, RMCS D had cleared the berry vines at the downstream spillway and outlet channel (Photo 3).

Photo 1: View of the upstream face from near the right abutment looking towards the left.

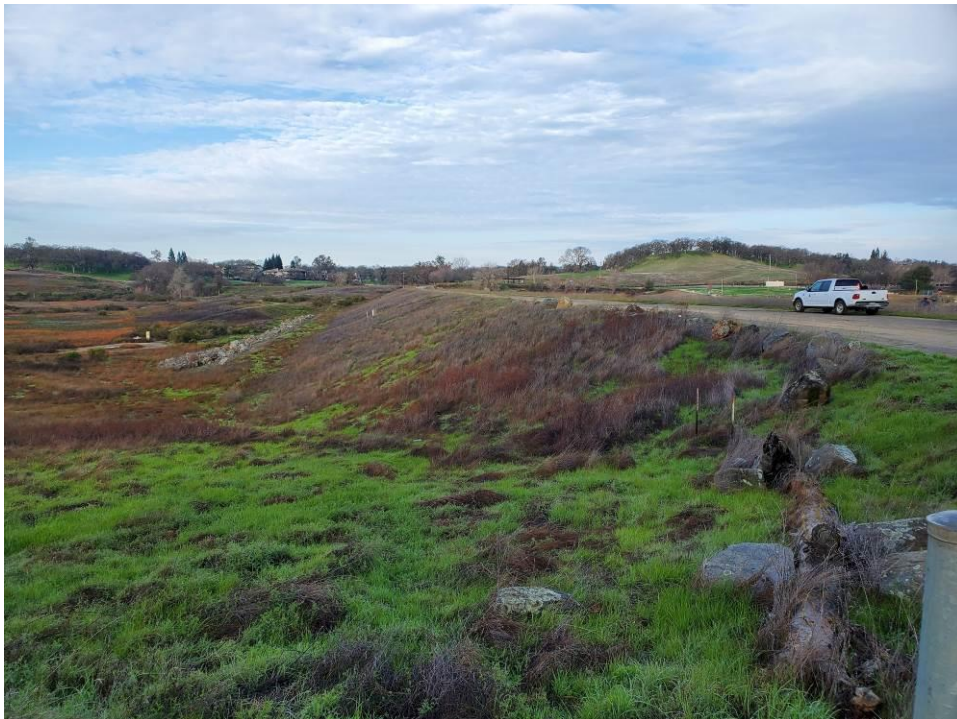
Photo 2: View of the downstream face from near the left abutment looking towards the right.

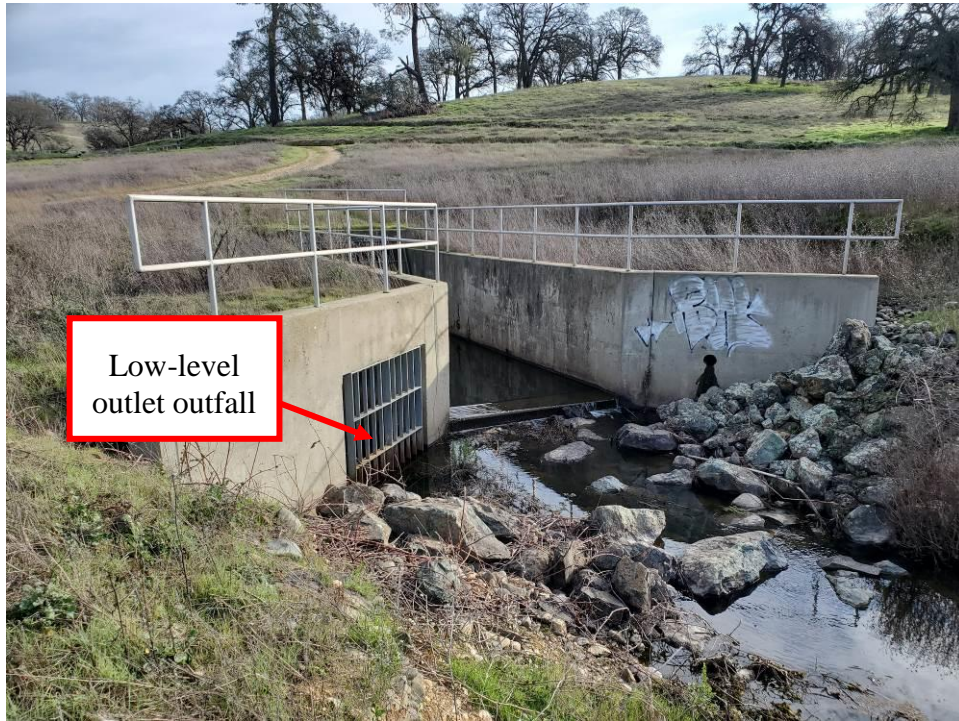
Photo 3: View of the spillway and low-level outlet outfall structure looking upstream.

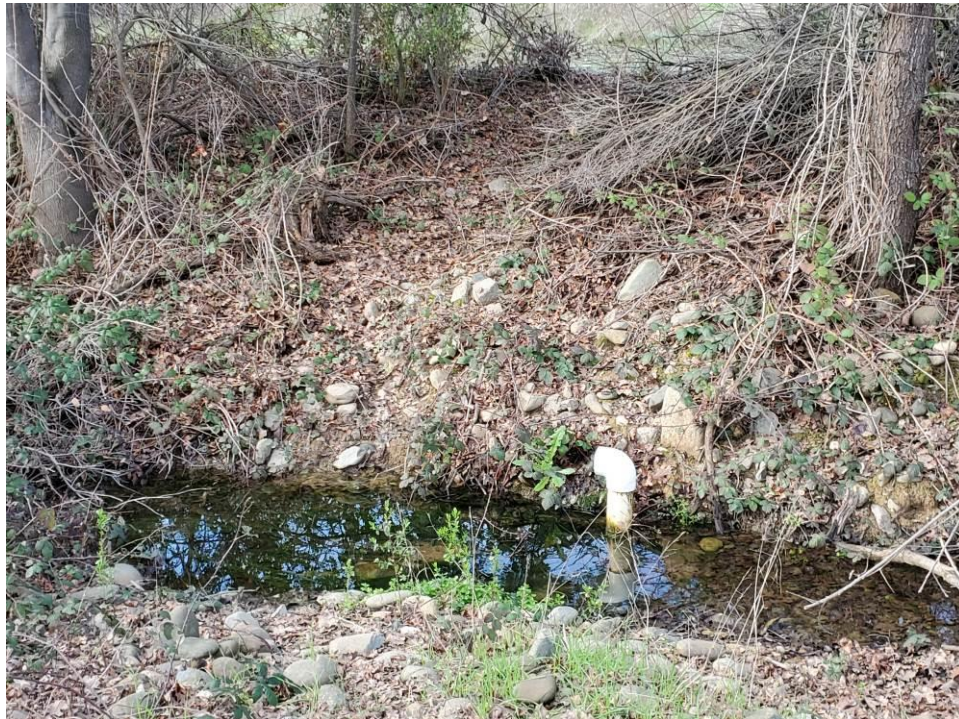
Seepage is collected in a sump at the toe of the dam and the sump pump is metered. Sump readings are recorded monthly and submitted with the annual instrumentation submittals. The outfall for the sump pump and the surrounding area were observed to be clear (Photo 4).

Photo 4: View of the seepage sump pump outfall in the ditch downstream of the toe of the dam.

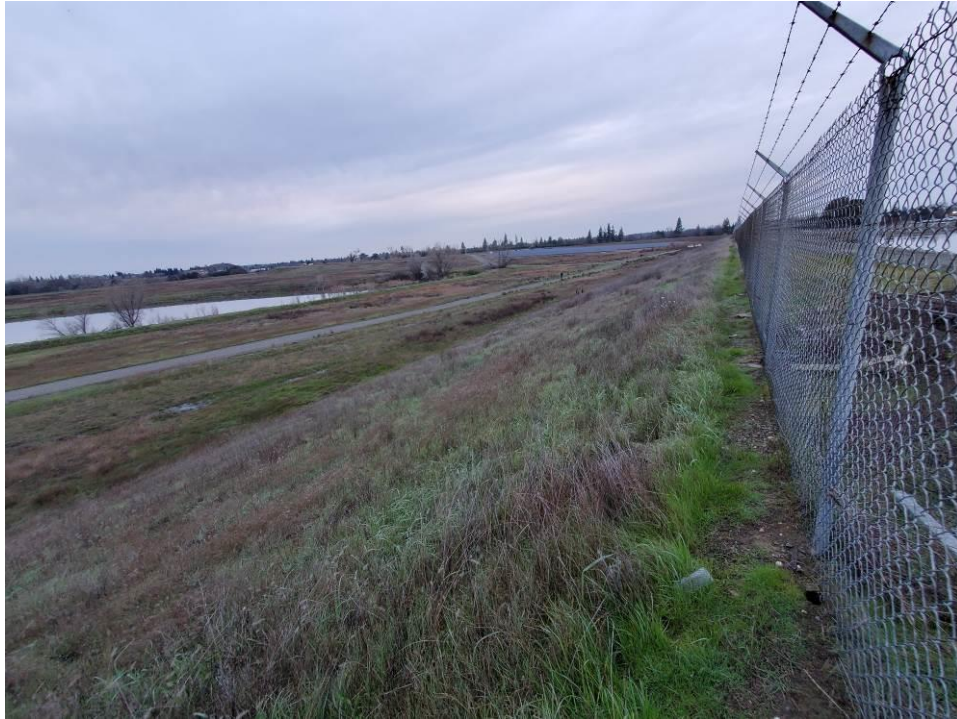
<u>Dam</u>	The dam has five ponds, but only the sections of embankment impounding Pond No. 3 and No. 5 are jurisdictional. I walked the crest and the western downstream toe (Photo 1). The visible upstream faces, crests, and downstream faces and groins were in satisfactory condition, showing no signs of instability or distress. Vegetation control was satisfactory. No major rodent activity was observed, but RMCS D needs to continue with their abatement efforts and collapse and backfill burrows with compacted material when encountered.
<u>Spillway</u>	The ponds are equipped with overflow structures that connect each pond. Pond No. 5 has a spillway pipe which discharges into Reservoirs No. 1 and No. 2 at Michigan Bar No. 1 Dam. The spillway pipe and each overflow structure were clear and unobstructed.
<u>Outlet</u>	The low-level outlet system is comprised of drain lines for both Ponds No. 3 and No. 5. The drains discharge into a diversion manhole located at the north end of the reservoir between Ponds No. 3 and No. 5. Each drain line is controlled by a slide gate located in the manhole. Releases then discharge through a single drain line into Michigan Bar No. 1 Dam (Photo 2). The slide gate which controls the drain line into Michigan Bar No. 1 Dam is left in the fully open position and the operating stem has been removed. The California Water Code section 6102.5(c) requires that the outlet controls be fully cycled by the owner annually, and in the presence of DSOD every three years. The controls for Ponds No. 3 and No. 5 were fully cycled in the presence of DSOD on February 10, 2022. They are due to be cycled in the presence of DSOD again during the next inspection.

Photo 1: View of the downstream face and toe on the west side of the ponds.

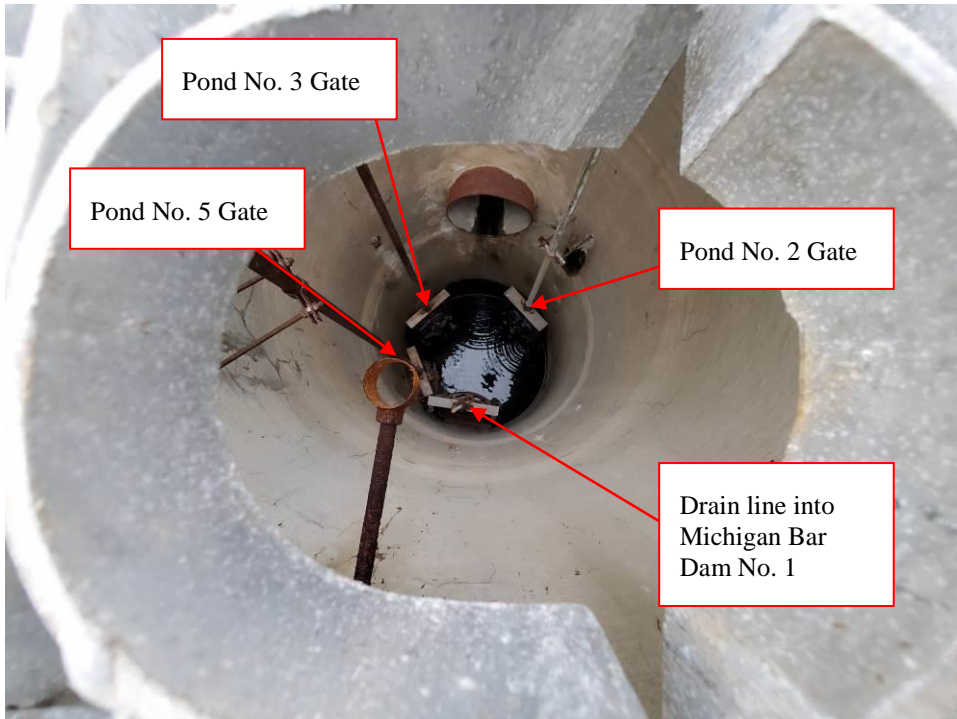
Photo 2: View into the diversion manhole.
