“Full” Reserve Study

RMCS D – Administrative Department Rancho Murieta, CA

Report #: 27003-0 ADMIN
For Period Beginning: July 1, 2015
Expires: June 30, 2016

Date Prepared: January 21, 2015

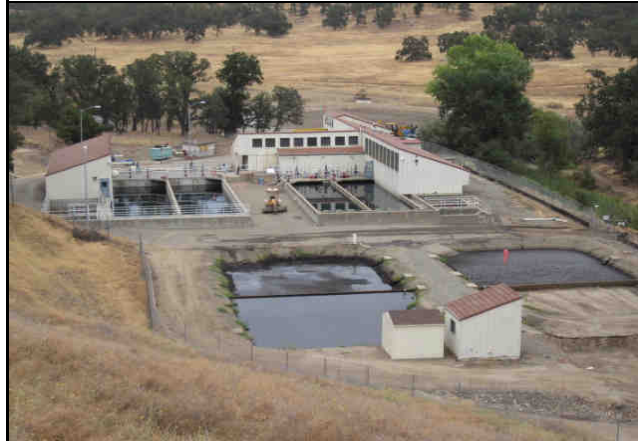
Evaluation : The water treatment facility is currently under construction. Plant 1 will be completely demolished and replaced with a membrane facility. This component provides funding to replace membranes roughly every 5-10 years.

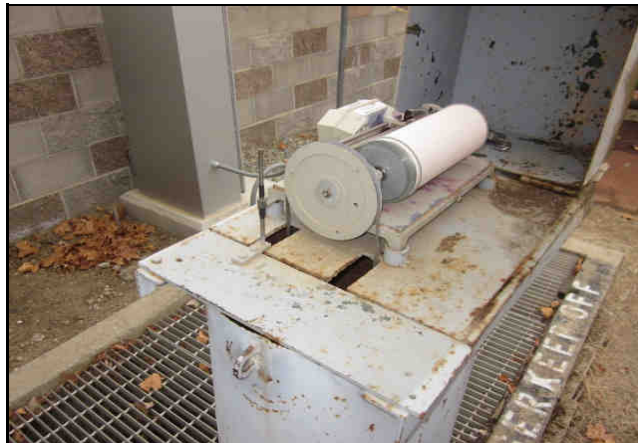
Evaluation : Flow sensor at the Equestrian Arena was installed in 2013. Currently no problem are reported. Plan on repairs or partial replacement at roughly the interval listed below.
