IMPROVEMENTS COMMITTEE (Directors Randy Jenco and Martin Pohl)

MEMORANDUM

Date: May 7, 2024
To: Improvements Committee
From: Travis Bohannon – Interim Director of Operations
Subject: Monthly Improvements Committee Updates

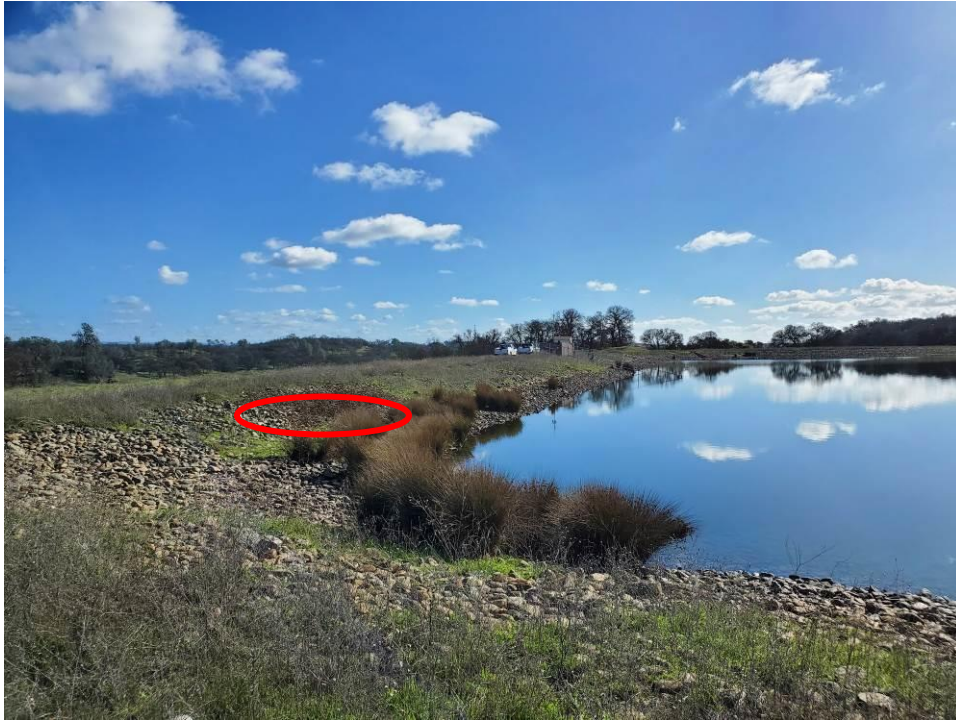
Photo 1: View of the upstream face of the Middle Dam (near) and South Dam (far) from the left side of the Middle Dam looking towards the right. The berry vine growth in the red circle needs to be removed.

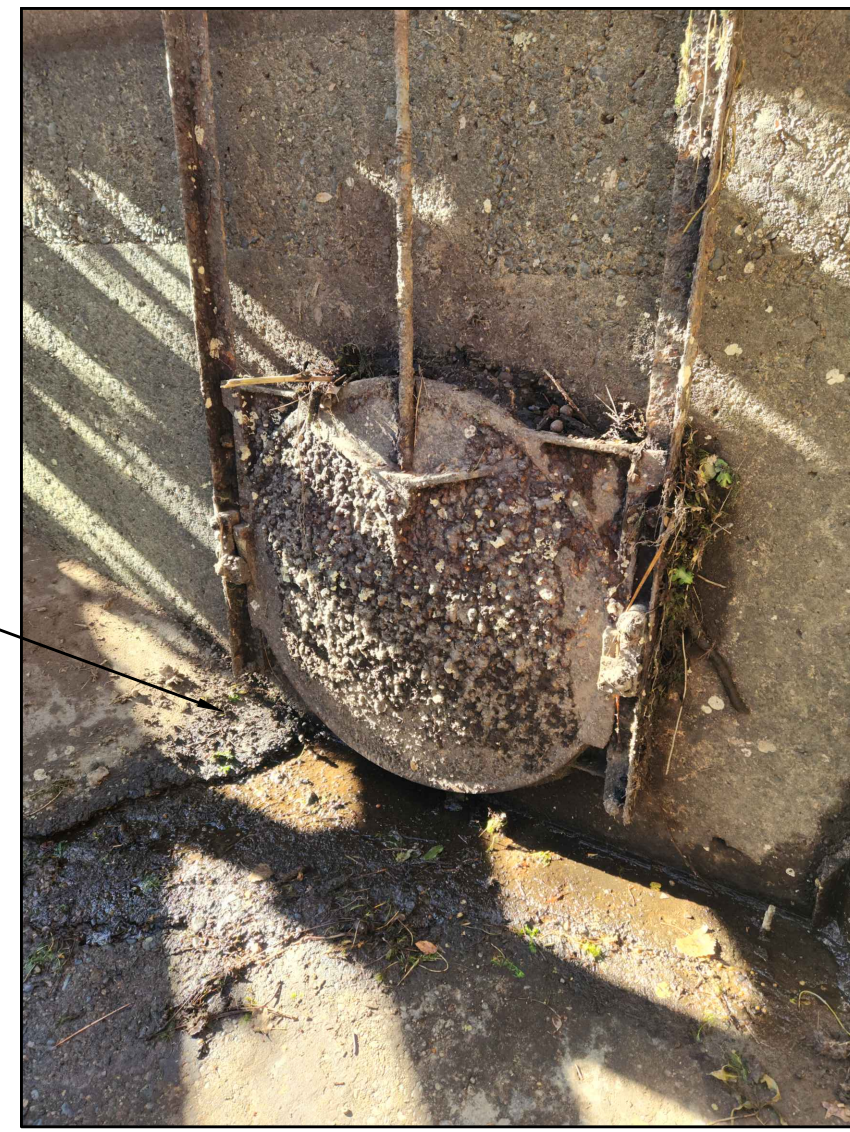
DETAIL PHOTO 1
SCALE: NTS

AREA TO BE CHIPPED OUT FOR NEW GATE, PATCH AS NEEDED TO LEAVE A SMOOTH FINISH
