“Full” Reserve Study

RMCS D – Administrative Department Rancho Murieta, CA

Report #: 27003-0 ADMIN
For Period Beginning: July 1, 2015
Expires: June 30, 2016

Date Prepared: January 21, 2015

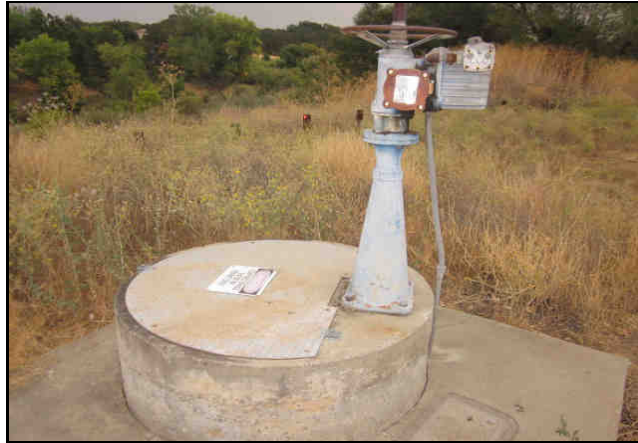
Useful Life:
30 years

Remaining Life:
7 years

Best Case: \$741,500

Worst Case: \$890,000

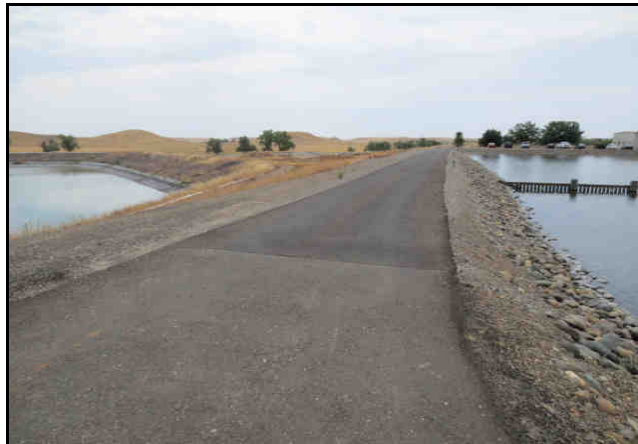
Useful Life:
100 years

Remaining Life:
62 years

Best Case: \$300,000

Worst Case: \$500,000

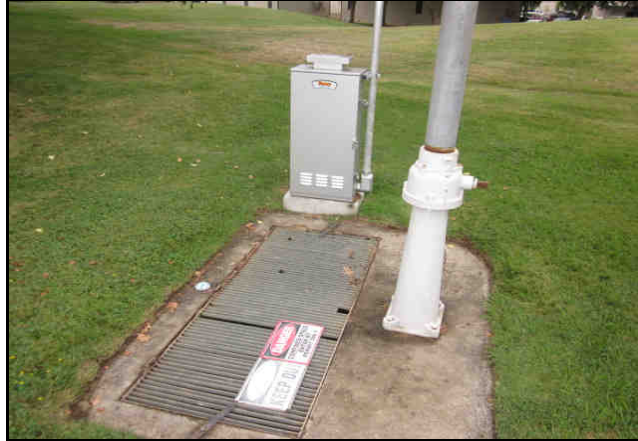
Useful Life:
20 years

Remaining Life:
12 years

Best Case: \$50,000

Worst Case: \$60,000

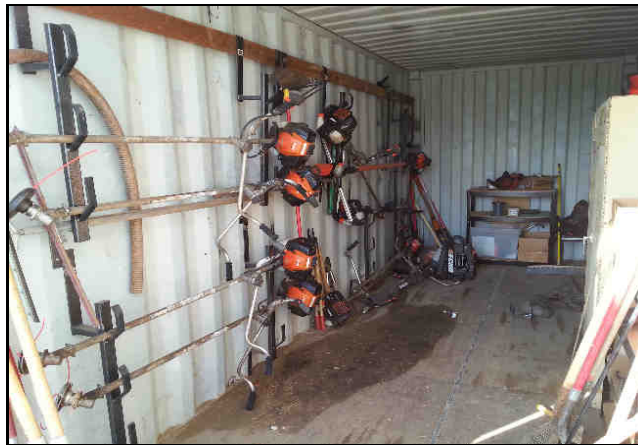
Useful Life:
10 years

Remaining Life:
5 years

Best Case: \$15,000

Worst Case: \$18,000

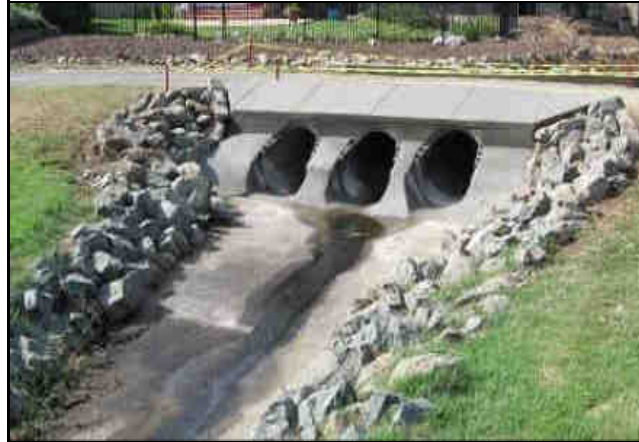
Useful Life:
5 years

Remaining Life:
1 years

Best Case: \$85,000

Worst Case: \$102,000

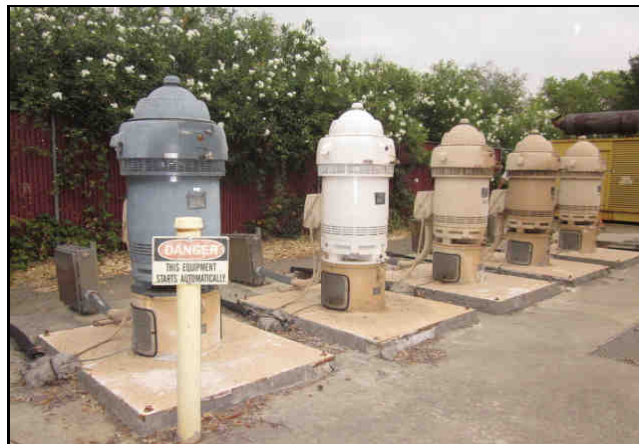
Useful Life:
20 years

Remaining Life:
10 years

Best Case: \$100,000

Worst Case: \$150,000

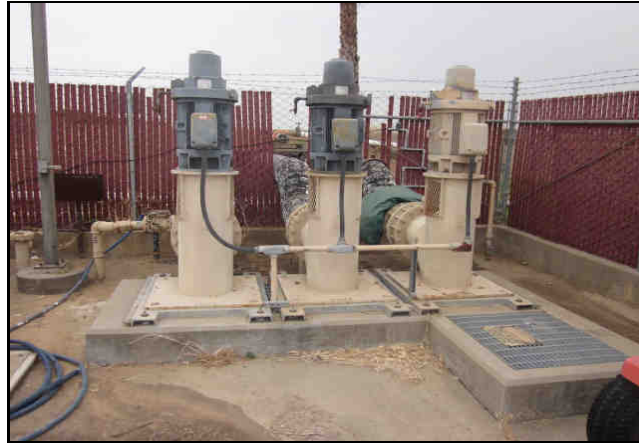
Useful Life:
20 years

Remaining Life:
10 years

Best Case: \$20,000

Worst Case: \$40,000

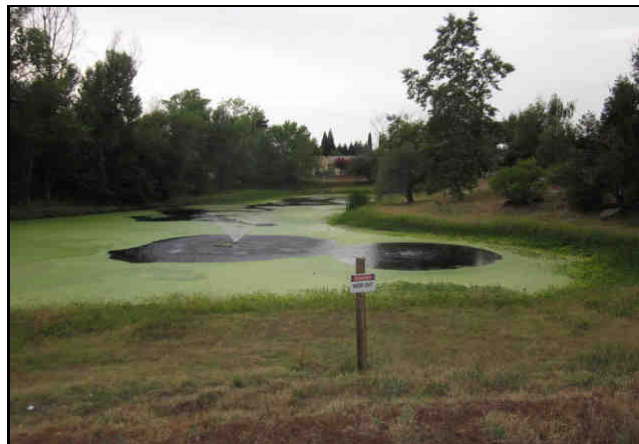
Useful Life:
25 years

Remaining Life:
15 years

Best Case: \$50,000

Worst Case: \$330,000

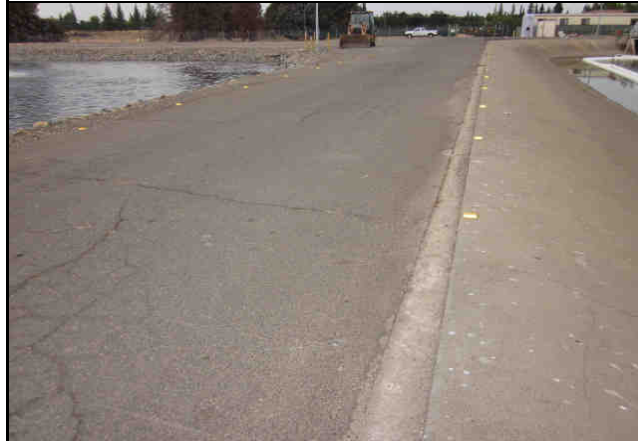
Comp # : 203 Asphalt - Seal/Repair

Evaluation : We recommend having surface sealed and repaired regularly for maximum design life. Even with ordinary care and maintenance, plan for eventual large scale resurface at roughly the time frame below.

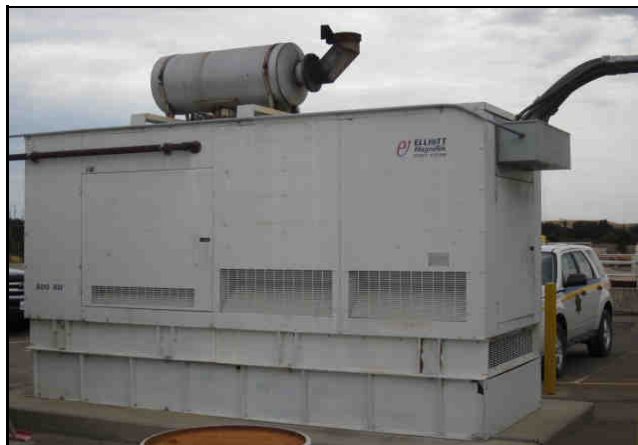
Comp # : 302 Generators - Replace

Evaluation : In good condition. No issues reported at the time of site visit. Provide regularly inspection and maintenance. We recommend setting aside funding for replacement at roughly the interval below. Update timing and cost as future needs dictate.

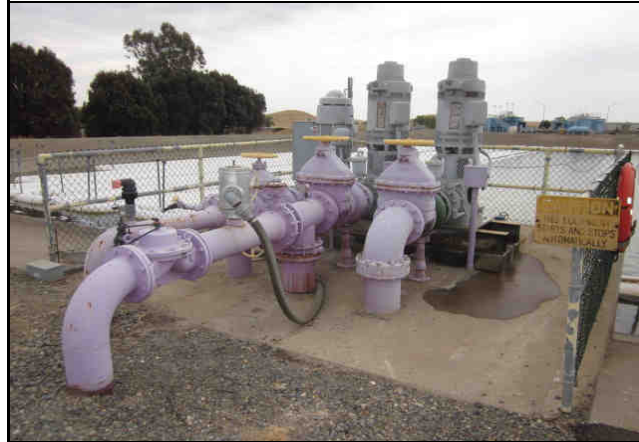
Comp # : 312 Pumping Stations - Repair

Evaluation : There are (3) Pump stations, (9) pumps, located at the WWT Facility; Tertiary Pump Station, Backwash Pumps, Reclaimed Water Pumps, This component provides funding for periodic repairs to pumps and controls as needed at roughly the interval below.

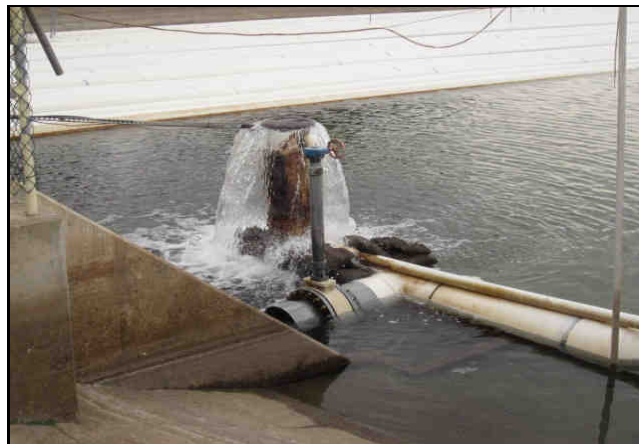
Comp # : 313 Tertiary Effluent - Replace

Evaluation : Filtered Tertiary Effluent into Equalization Basin. Effluent appeared to be in good condition and functional during our site inspection. This component provides funding for replacement at roughly the interval below. Update as future needs dictate.

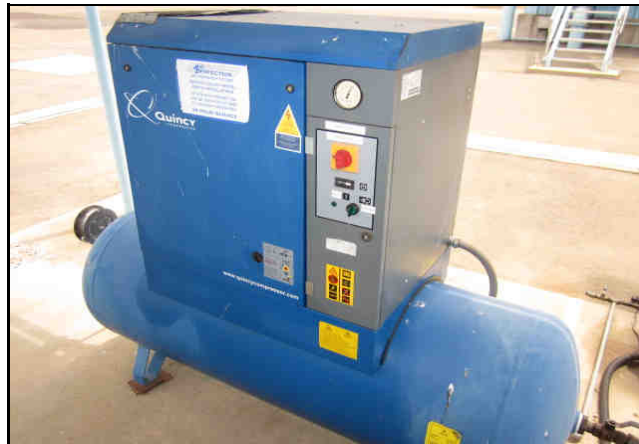
Comp # : 336 Air Compressors - Replace

Evaluation : No issues reported. This component provides funding to replace air compressors at roughly the interval below.
Update timing and cost as future needs dictate.

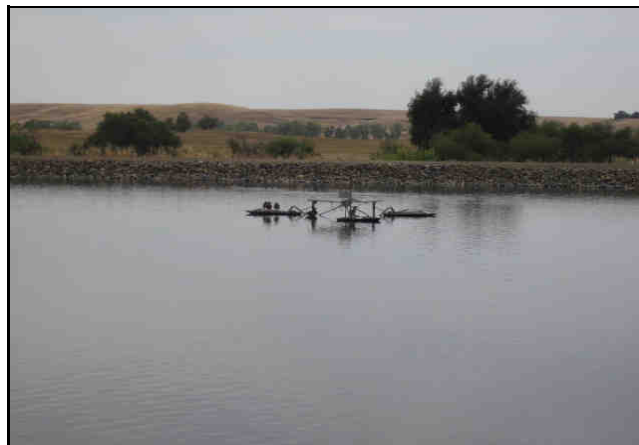
Comp # : 337 Solar Pond Circulator - Replace

Evaluation : Unable to inspect closely. Assume functional. Due to technology, we recommend replacement of the pond circulators at roughly the interval below. Update as future needs dictate.

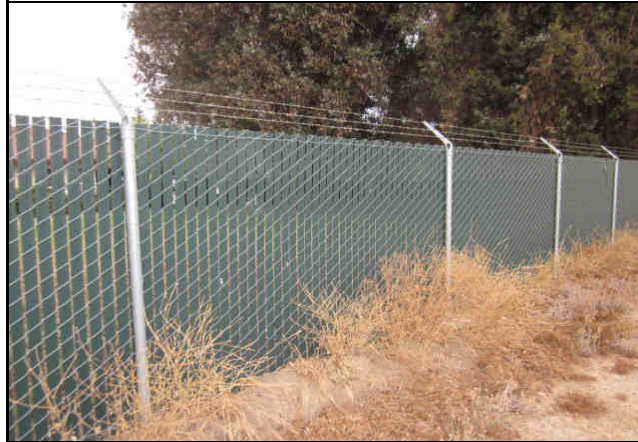
Comp # : 521 Fencing - Replace/Repair

Evaluation : Fencing surrounds the WWT Facility with (1) vehicle entrance gate operated by a barcode reader system. Fencing is in good condition with no major damage or gaps noted. Plan for repairs/ partial replacement at roughly the interval below.

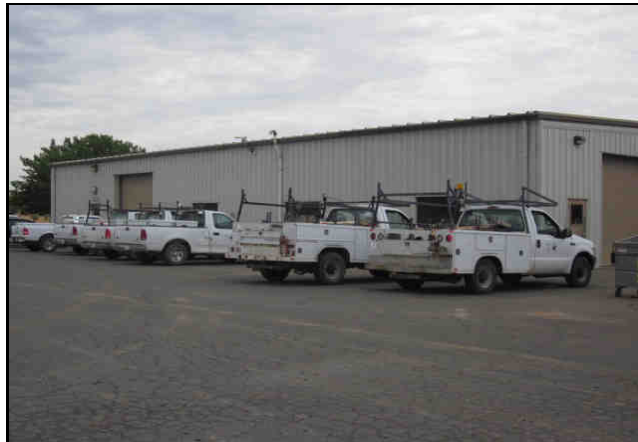
Evaluation : (2) Storage buildings in the WWT Facility. One enclosed storage building and one open-air storage shed structure. No expectation to replace either building completely. This component provides funding for general refurbishment at roughly the interval below.

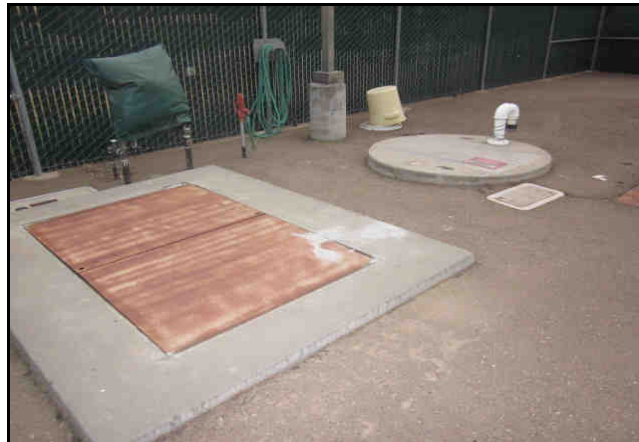
Evaluation : The Crest sewage lift station serves to pump sewage to Main Lift South. The pump station has (2) 8" sanitary sewer inlets and (1) 6" force main that runs up Murieta South parkway ultimately into Main Lift South with approx 1,490LF of piping. Equipment includes; (2) 10HP submersible pumps; a Tesco L2000 controller; a Cummins transfer switch; Microtel DialStat auto-dialer; a 6" Sparling magnetic flow meter; a 68hp diesel generator; and a 113 Gallon Fuel Tank. This component provides funding for minor reconstruction, including repair/replacement of pumps and stainless steel guide rails every 15 years.

Useful Life:
15 years

Remaining Life:
2 years

Best Case: \$40,000

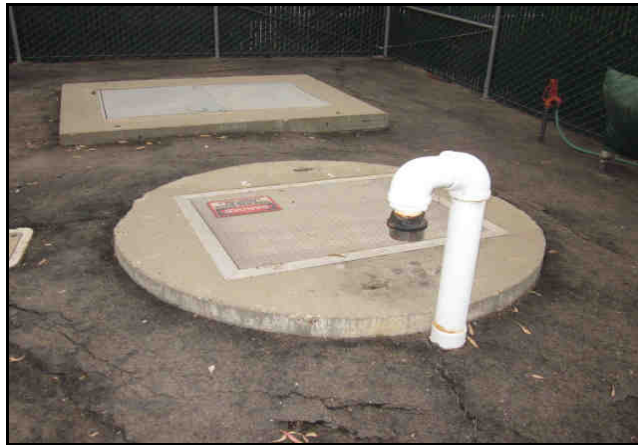
Evaluation : The Greens sewage lift station serves to pump sewage to Main Lift South. Station has (1) 6" inch sanitary sewer inlets and (1) 4" force main that runs up Bent Grass Court, north on Colbert Drive and ultimately flows into Main Lift South with approx 670LF of piping. Equipment includes; (2) 3HP submersible pumps; Tesco L2000 controller, a Cummins transfer switch; a Sensaphone auto-dialer; 24.3 HP diesel generator; and a 106 gallon diesel storage tank. This component provides funding for minor reconstruction, including repair/replacement of pumps and stainless steel guide rails every 15 years.

Useful Life:
15 years

Remaining Life:
1 years

Best Case: \$30,000

Worst Case: \$40,000

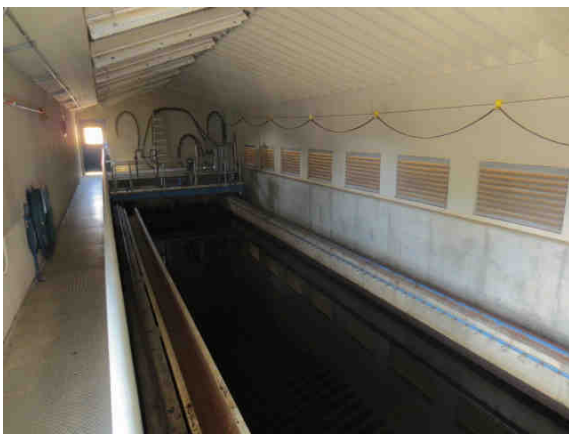
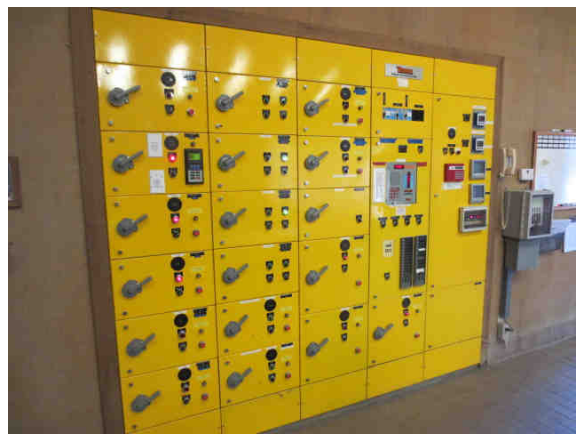
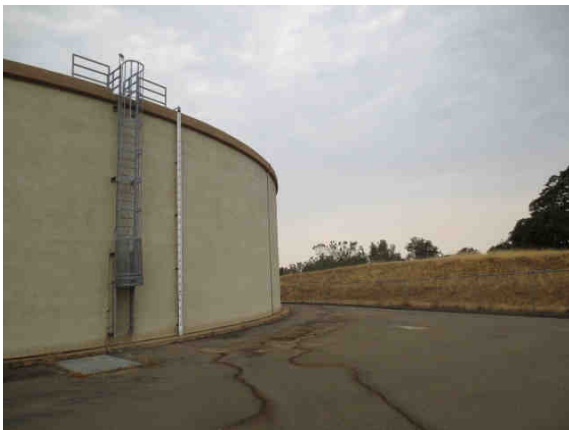
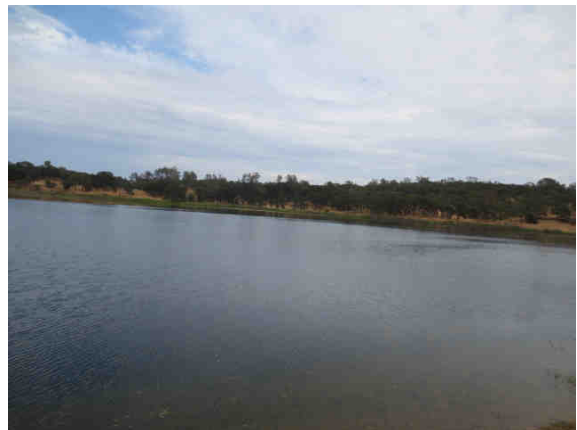
Site Inspection Notes

During our site visit on August 4, 2014, we started with a brief meeting with Paul Siebensohn (Director of Field Operations), and then started the site inspection beginning with the reservoirs. We visually inspected the entire property, and were able to see most areas including Granlees and the Water Plant construction. We were not able to inspect the pipelines.

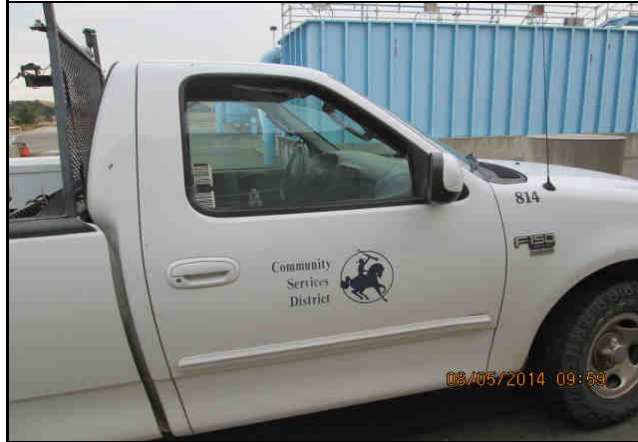
Comp # : 1865 2003 Ford F150 - Replace

Evaluation : 2003 Ford F150. Current mileage: 111,806. In good condition. No major damage noted. The useful life varies on use and should be updated in future reports. Timing for replacement is based on usage and reflects the expectation to replace the vehicle once it reaches 100,000 miles.

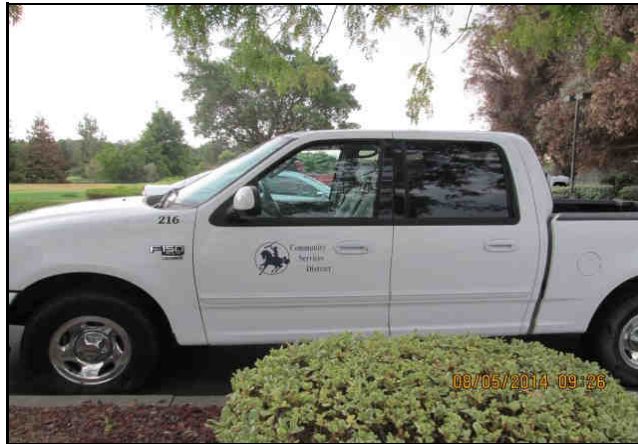
Comp # : 1866 2003 Ford F150 Supercrew - Replace Quantity: (1) Ford F150, V#3233

Evaluation : 2003 Ford F150 Supercrew. Current mileage: 33,544 In good condition. No signs of major dents or paint chipping. The useful life varies on use and should be updated in future reports. Timing for replacement is based on usage and reflects the expectation to replace the vehicle once it reaches 100,000 miles.

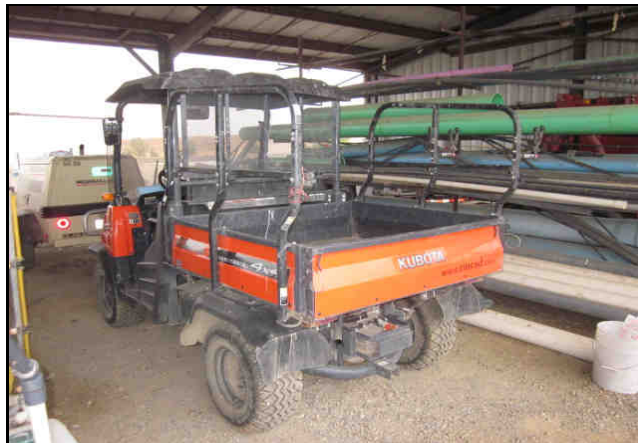
Comp # : 1870 **Utility Vehicle - Replace** Quantity: (1) Utility Vehicle

Evaluation : Vehicle is in good condition. Expected wear and tear. Stored in a semi-protected location. We recommend setting aside funding to replace at roughly the interval below.

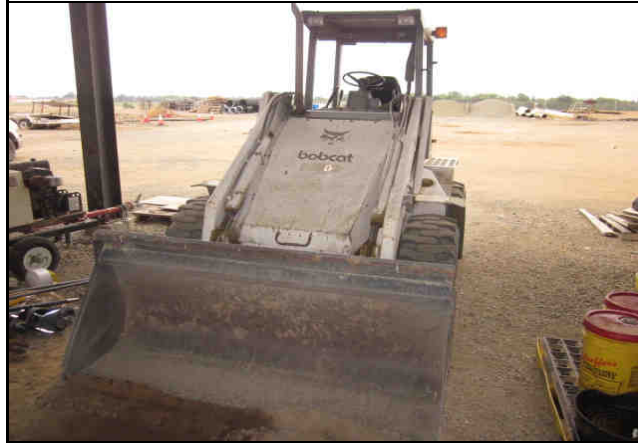
Comp # : 1873 Bobcat Tractor - Replace Quantity: (1) Bobcat Comp. Tractor

Evaluation : Bobcat compact tractor is in good condition. Stored in a semi-protected location. We recommend setting aside funding to replace at roughly the interval below.
